Fukushima

status for en igangværende ulykke

IDA 18 maj 2011

Erik Nonbøl, Risø DTU

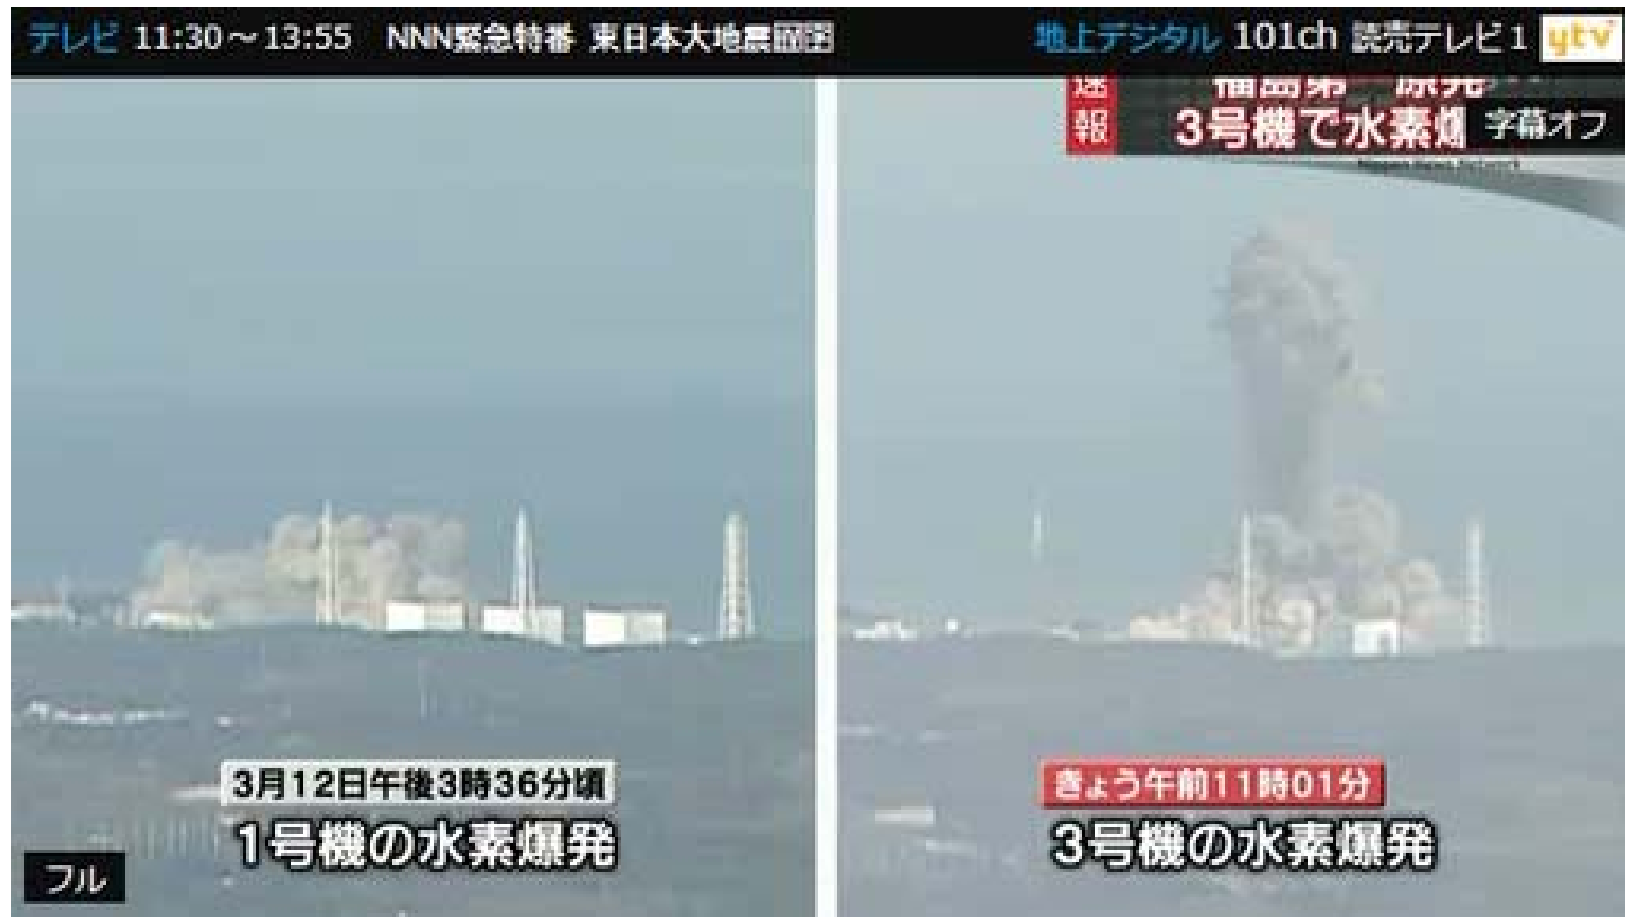
Hydrogen explosion at Unit 1 & 3

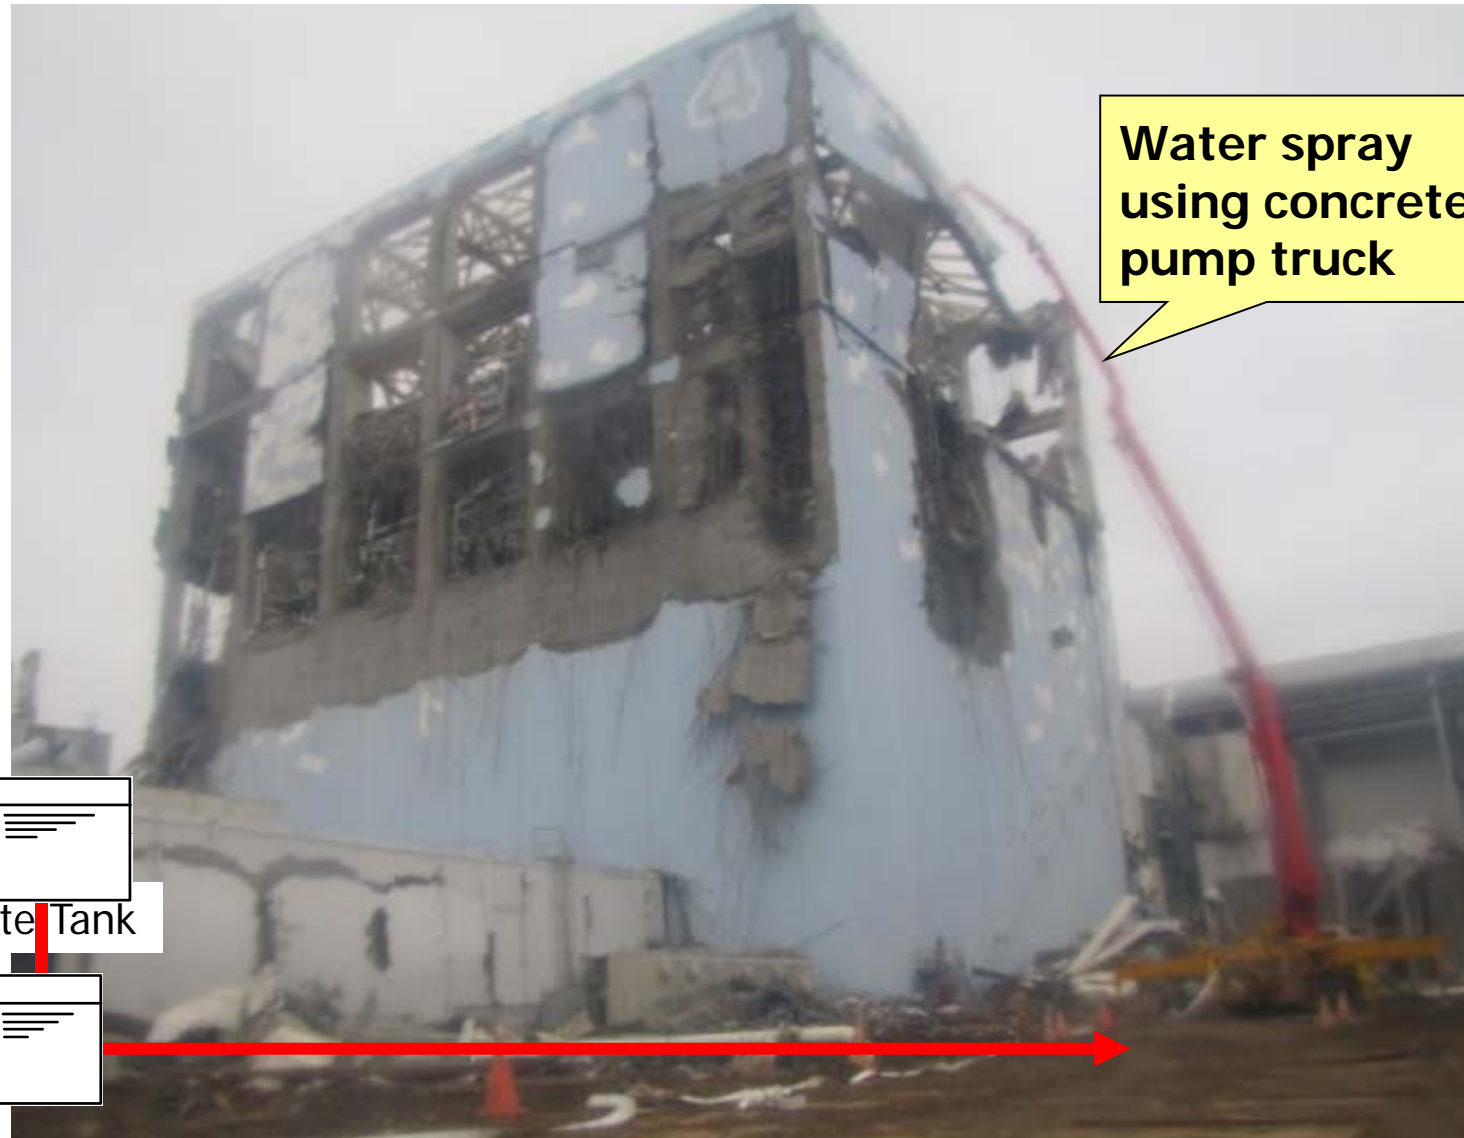
Water spray into the SFP of Unit 4 using concrete pump truck
